STAGE 1 FAN BLADE

Engine Manual 72-21-01

Aircraft Type : A319, A320, A321

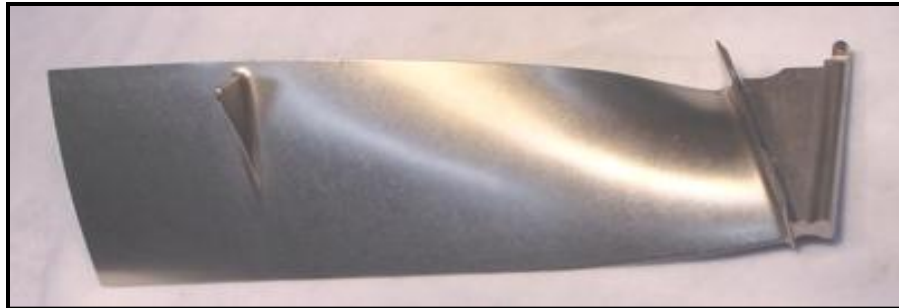
Solid Titanium Design, Midspan Shrouds, 36 Blades per Engine
